Struve Geodetic Arc: National Report of Estonia

Estonian Land Board / Head of the Department of Geodesy
12-14.09.2018

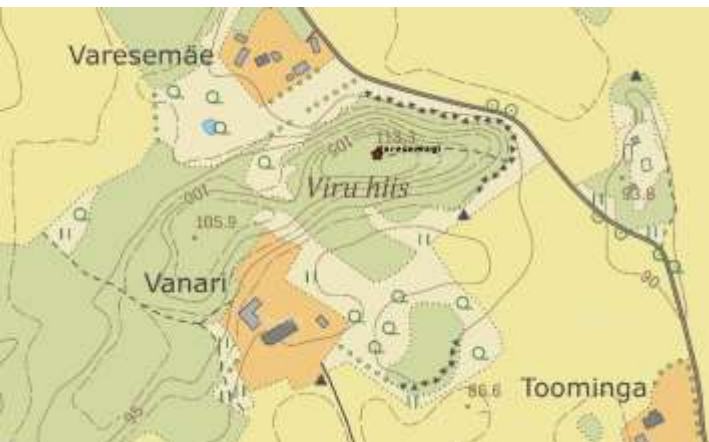
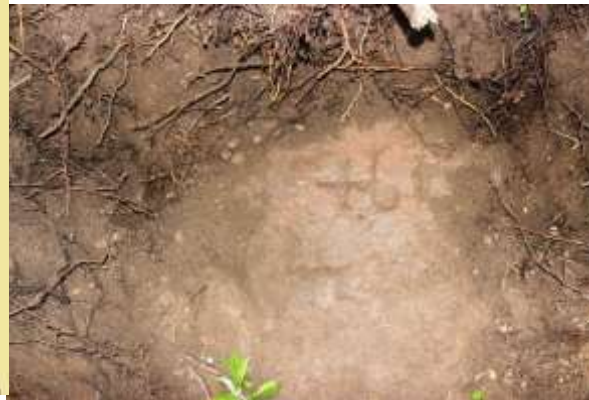
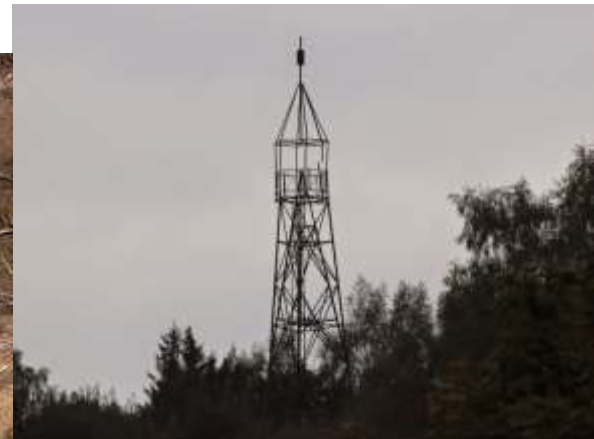
LEVALA

Struve's point is probably situated 13 m in NW direction from trigonometric point Levala

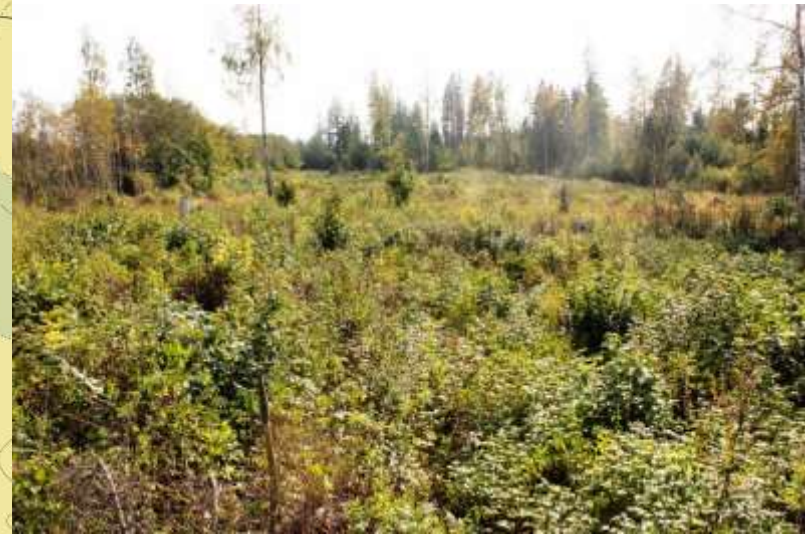
RAEKÜLA

No trigonometric points nearby

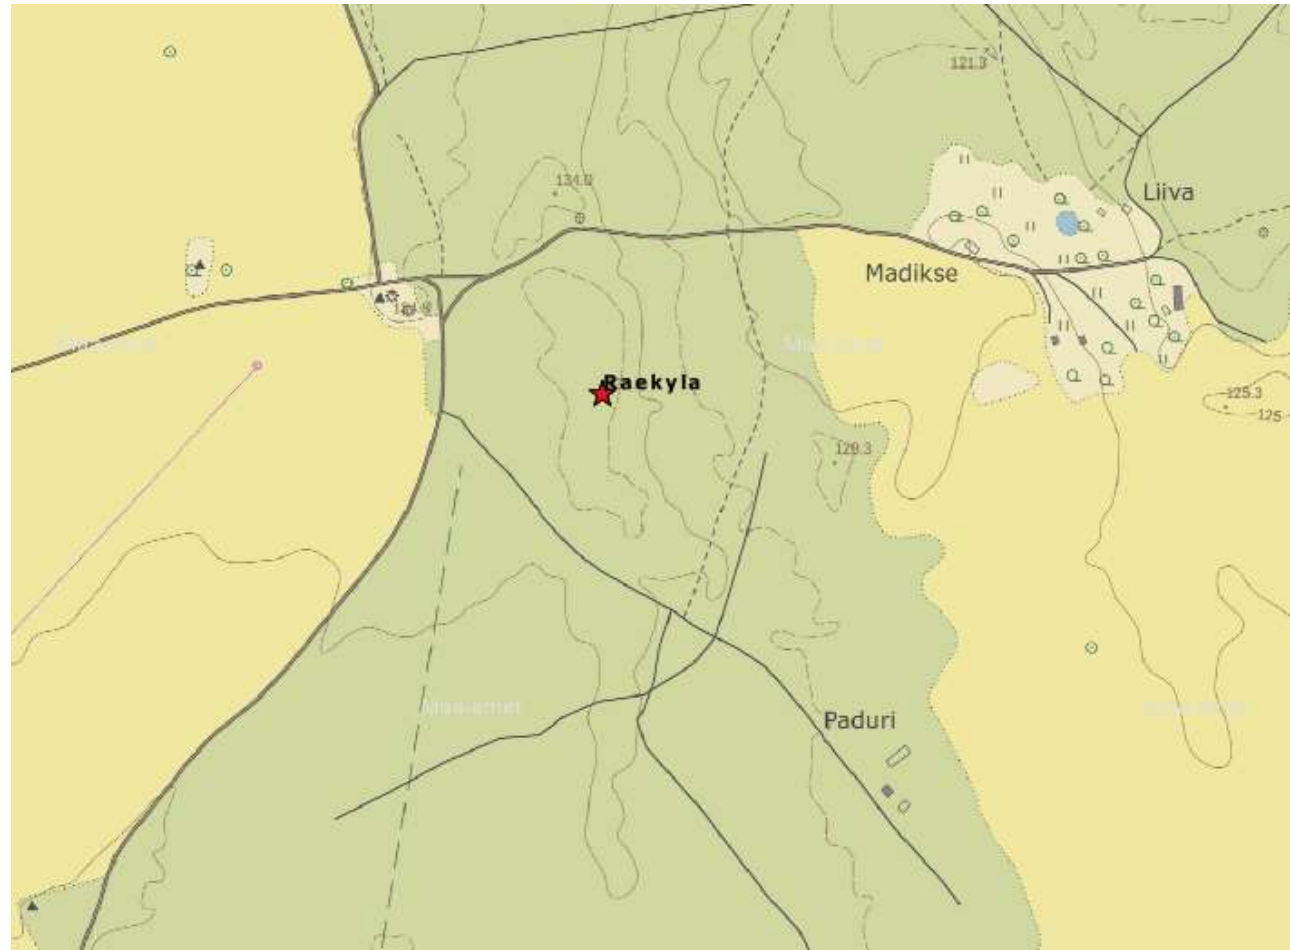
EBAVERE

The triangulation point by the same name („*Ebavere*“) has been used in the Estonian geodetic networks in 1856, 1895 and 1931

Inspection in July 1991

Struve's point is situated 2.5 m in SE direction from the known point *Ebavere*

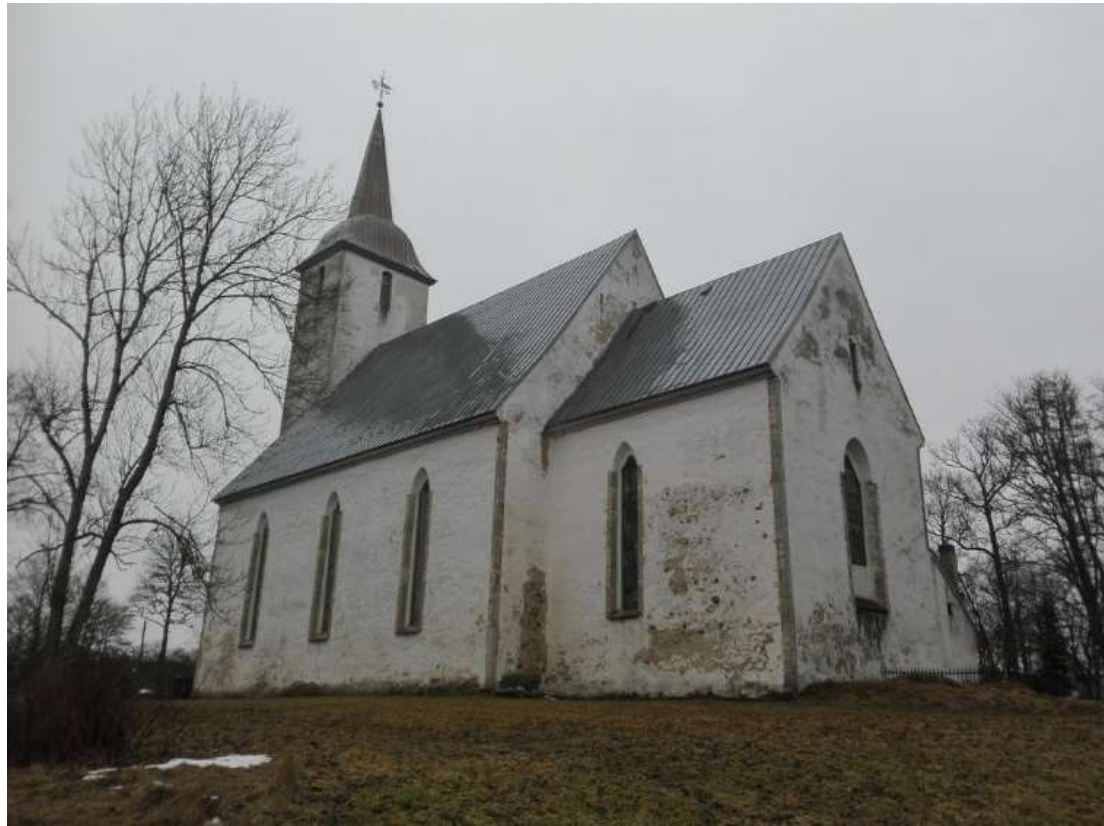
TAMMIKU

The triangulation point by the same name („*Tammiku*“) was established in 1961

Struve's point is situated 840* m in SE direction from the known point *Tammiku*

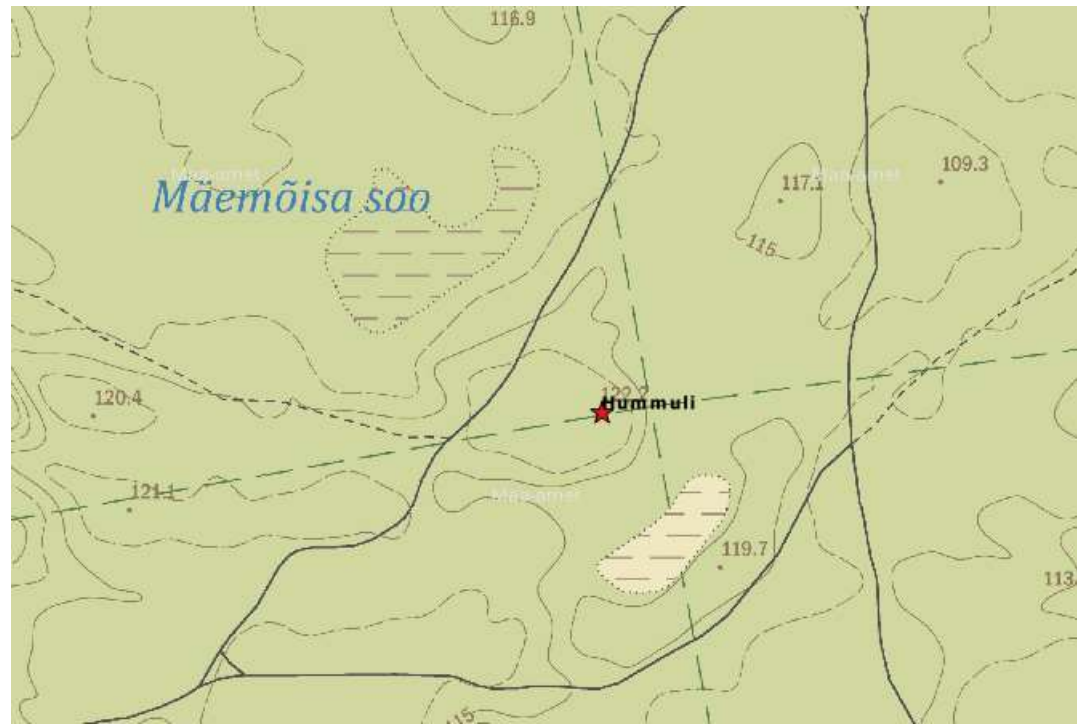
HUMMULI

The triangulation point by the same name („*Hummuli*“) has been used in the Estonian geodetic networks in 1903, 1933 and 1991

Inspection in June 1991

Struve's point is situated 1500 m in SW direction from the known point *Hummuli*

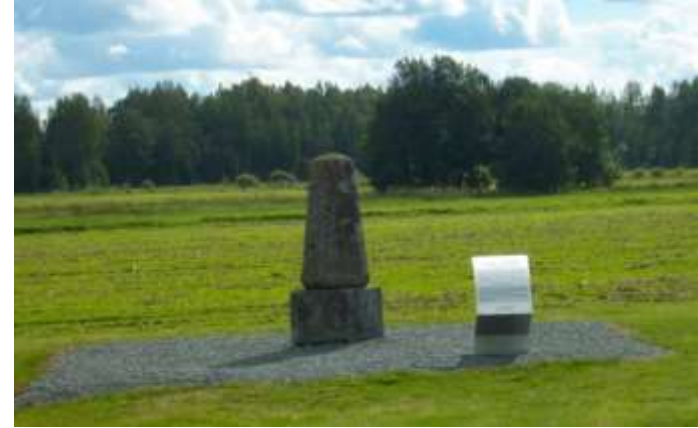
SIMUNA

In 1827, the end point was established from limestone foundation (204*204 m), rectangular granite block, where the center was marked as drilled hole

In 1849, the end point was marked with the granite block and conical granite pillar (1,7 m high) by F. Wrangell and F. Lütke

In 1870 Lieutenant Kortazzi, at the request of Otto Struve, carried out an inspection of the endpoint of Simuna, the endpoint was in good shape

Recognition in 1935 showed that the endpoint had survived in its former state.

In 1947 Želnin found the endpoint at its former state. Although he discovered that the granite block was not connected to the foundation.

In 2001 at the inspection by ELB, it was found that two granite monoliths established in 1849 have shifted from the site and the metal center of the lower block has disappeared, its location was marked by a hole about 2 cm in diameter.

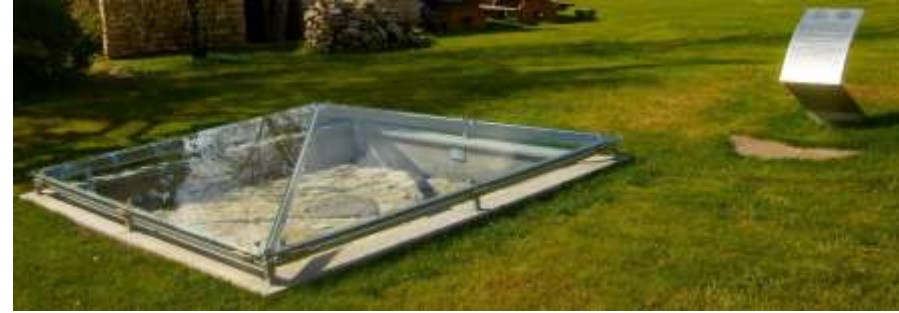
VÕIVERE

In 1827, a center was established similarly to the endpoint of Simuna.

At the request of Otto Struve in the 1870 survey, Lieutenant Kortazzi found that the rectangular granite block was shifted from its original location

1935, by the resolution of the Baltic Geodesy Commission, A. Vuuk did not find the foundation of the endpoint and considered it destroyed.

In 1947, Želnin and Maasik searched the endpoint in Võivere. They found a 204 cm x 204 cm limestone foundation at the depth of 0,7 meters, but there was no granite block placed on it.

At that time, Zelnin thought that, due to weather conditions (the work ended in November 1827), the endpoint was not correctly closed, which could cause displacement and disappearance of the granite block.

In 1964, Želnin wrote that only the limestone foundation was preserved at the baseline's endpoint in Võivere.

In 2001 at the inspection by ELB the limestone foundation was found in Võivere, but the center was marked by the large granite stone.

However, it is known that during the war (1941) the centerpiece of the granite plate was still in place.
